**ALLEGHENY COUNTY HEALTH DEPT
AIR QUALITY PROGRAM
INSPECTION REPORT**

Date(s) of Inspection: Aug. 4, 2021	Inspection Type: PCE On-Site	Source Type: Title V Major
Facility Name: United States Steel Corporation Clairton Works	Facility Location: 400 State Street Clairton, PA 15025 Facility Mailing Address: 400 State Street Clairton, PA 15025	Facility Contact: Mike Dzurinko Environmental Control Engr. Facility Phone #: 412-233-1015 Email: mdzurinko@uss.com
Comp. Mon. ID #:	MDR Spreadsheet Entry: <input type="checkbox"/>	Permit #: OP 0052
Name (Address) of Responsible Official: Kurt Barshick P.O. Box 878 Dravosburg, PA 15034		Title: General Manager U. S. Steel – Mon Valley Works

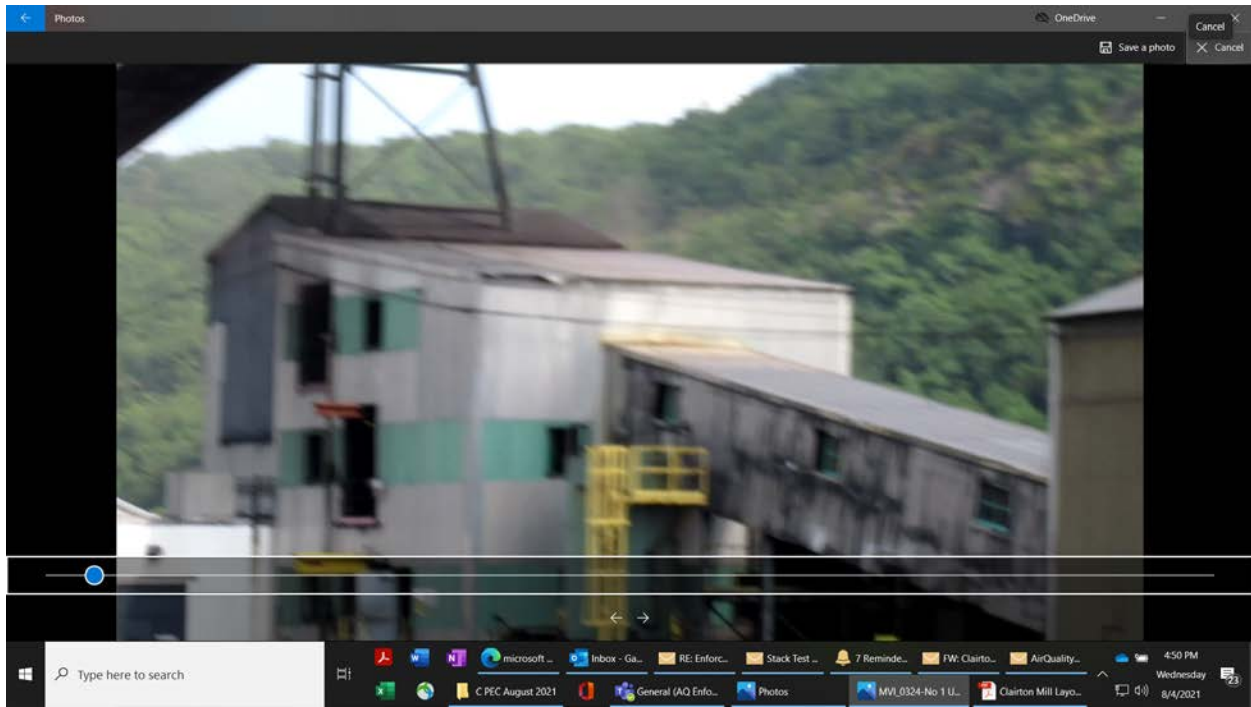
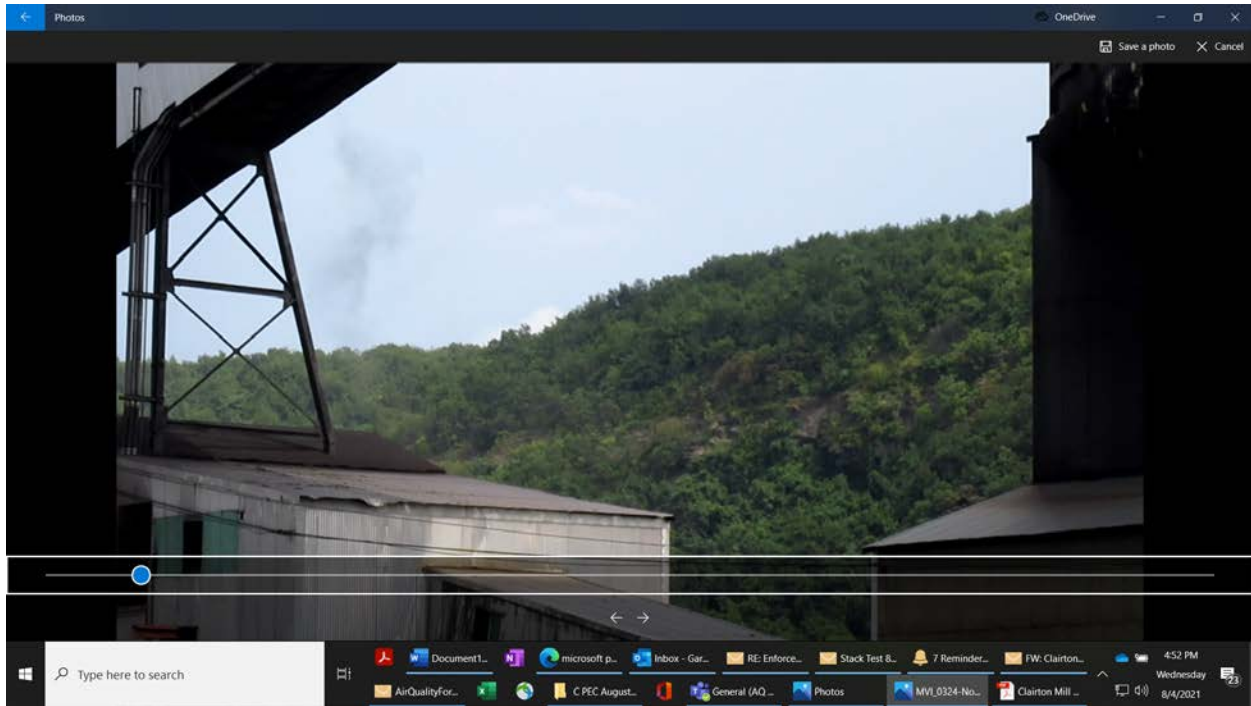
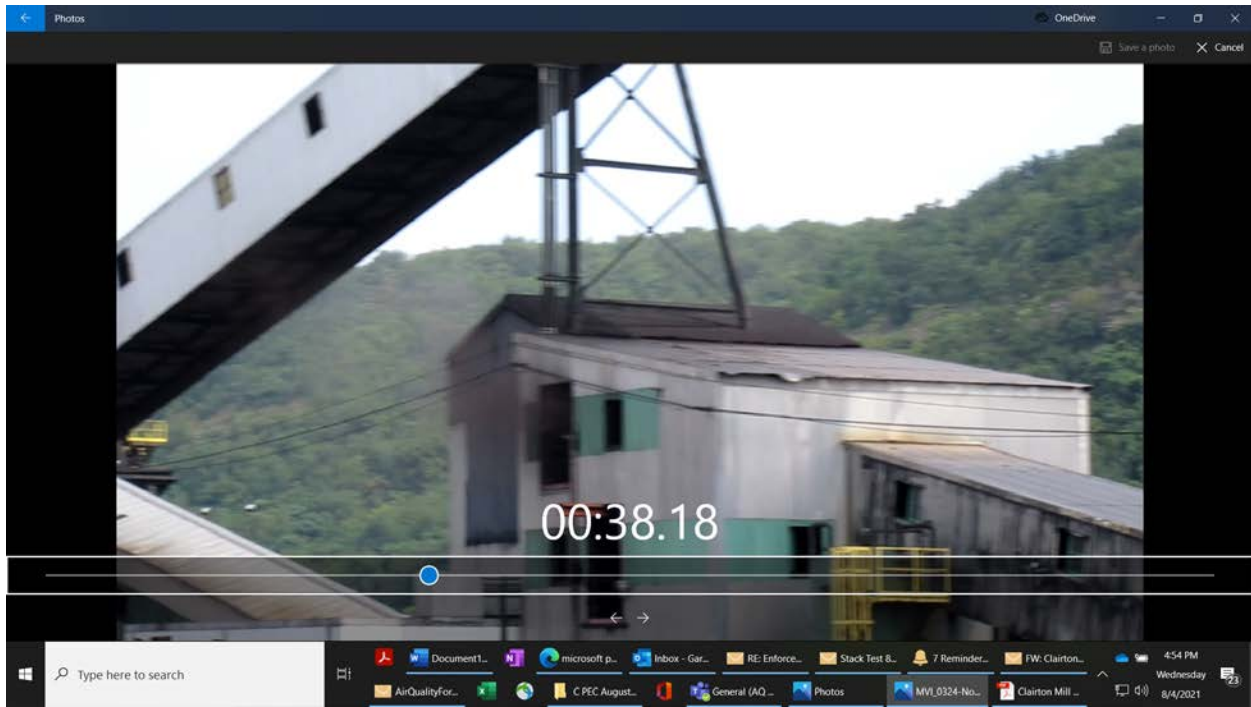
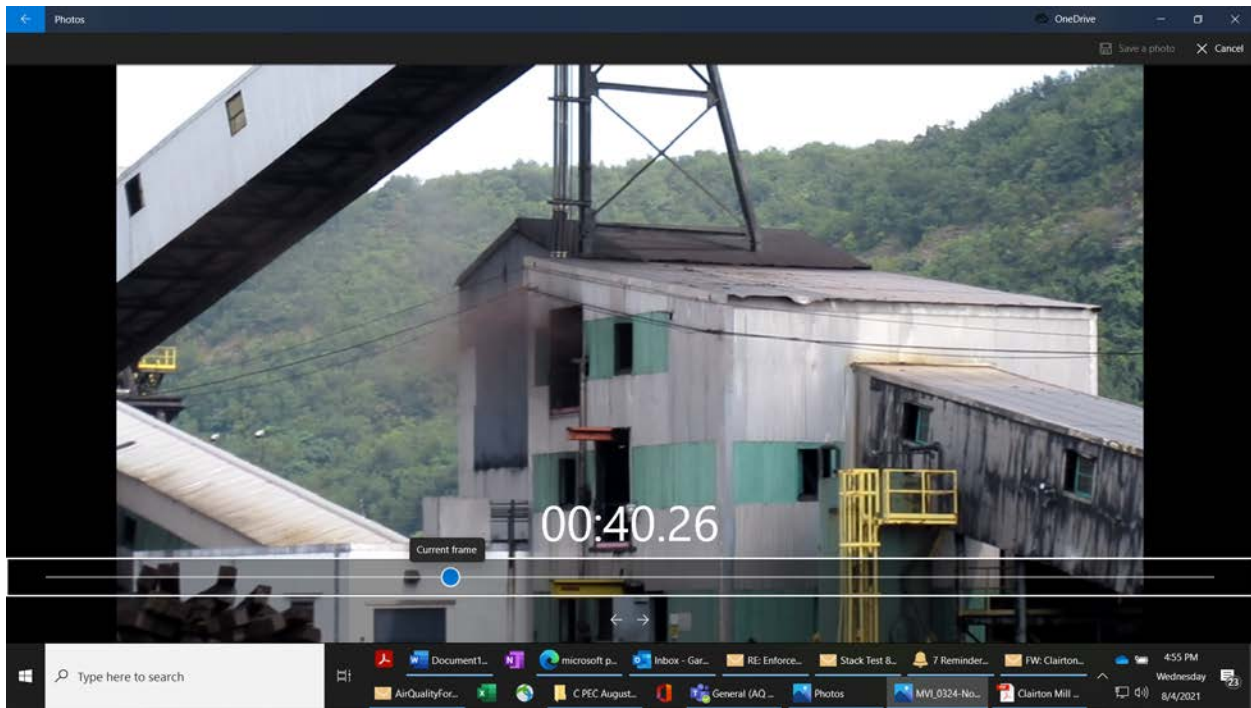
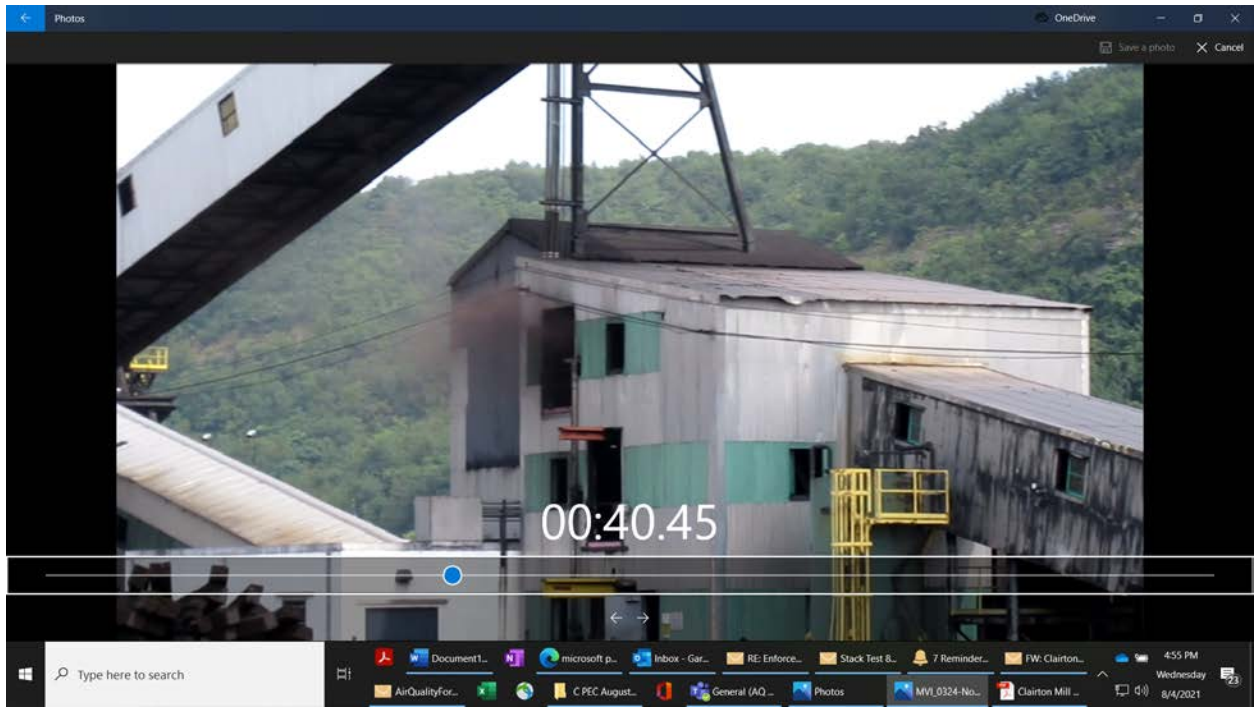
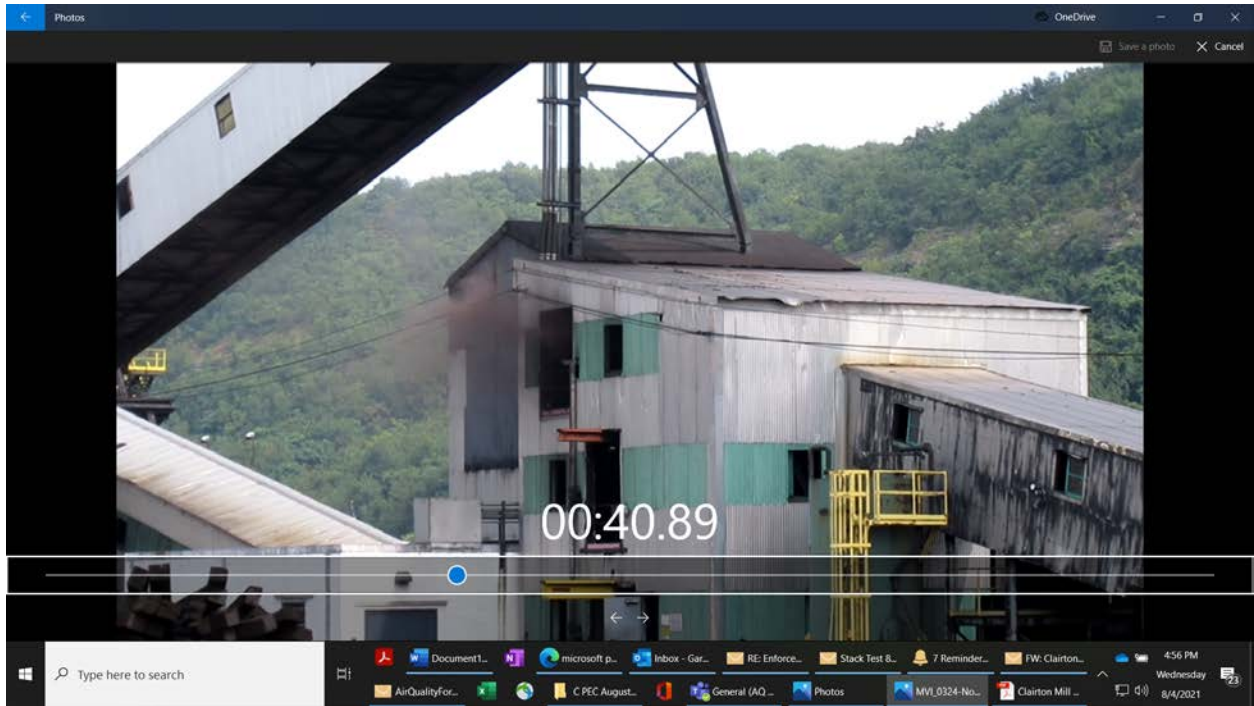
Following pushing observations during a compliance test for C Battery PEC Baghouse, the ACHD inspector and Veolia escort were returning to their vehicle when they noticed dust being emitted from the No. 1 Unit Pulverizer, located by the river alongside Batteries 7-9. The inspector and escort drove to a location with the sun at their backs and viewed the Pulverizer building from there. The view was downriver towards C and B Batteries. A brown plume was observed leaving the roof on the river side. Following this, a plume was observed leaving the roof on the side facing the batteries; this plume appeared black against a partly cloudy sky. Subsequently, a large plume was observed leaving a large window facing the batteries and traveling horizontally towards the batteries. This plume appeared brown with opacities intermittently exceeding 60% (as high as 75% was observed against a background of trees). Emissions were observed leaving this window for ~ 90 seconds. Photos and still shots from a video taken during this observation are attached to this report.
