# County of Allegheny

## 2015 Pre/**Post**-Election Air Gap Analysis of Election Tabulation Network

## **Overview**

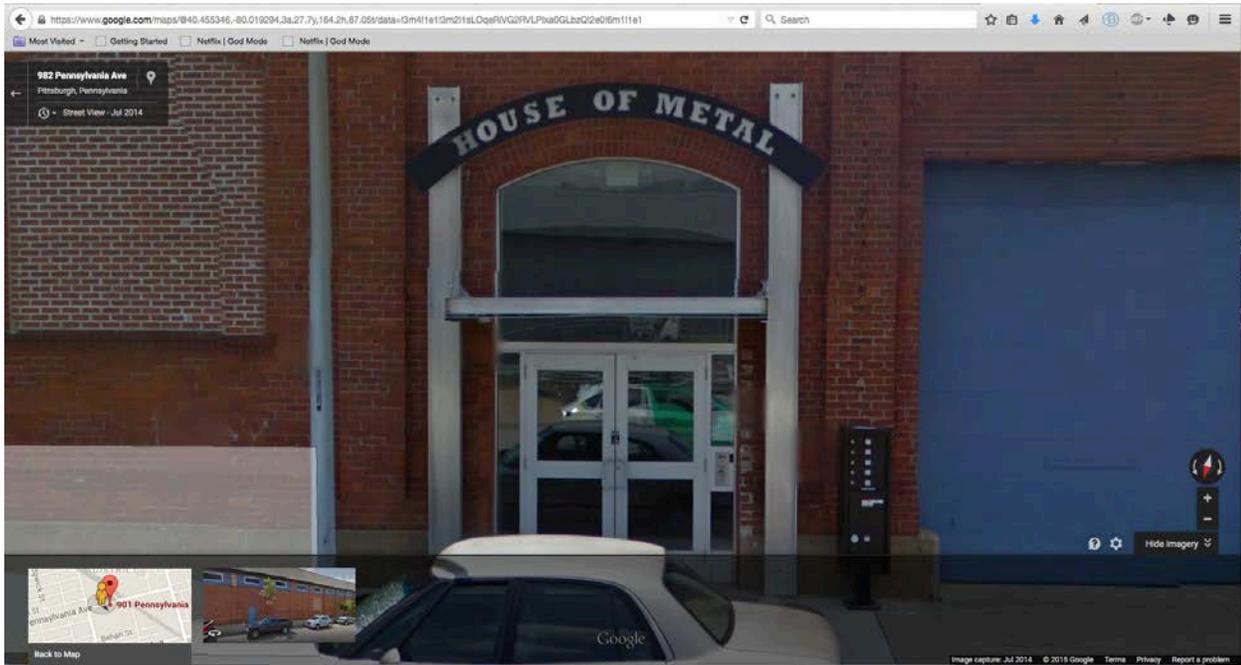
**Building Main Entrance:**

There are several suites within the warehouse and there were no outside signs, which identified the County of Allegheny building space. The building phone at the main entrance also did not have any entries to dial for the County of Allegheny.

Entrance from the street required badge card access. The first door in the warehouse required a security code, but it was a physical, non-electronic lock.

Security cameras were observed over the street entrance and inside the computer room. Cell phones were not permitted into the computer room that contained the tabulation network.

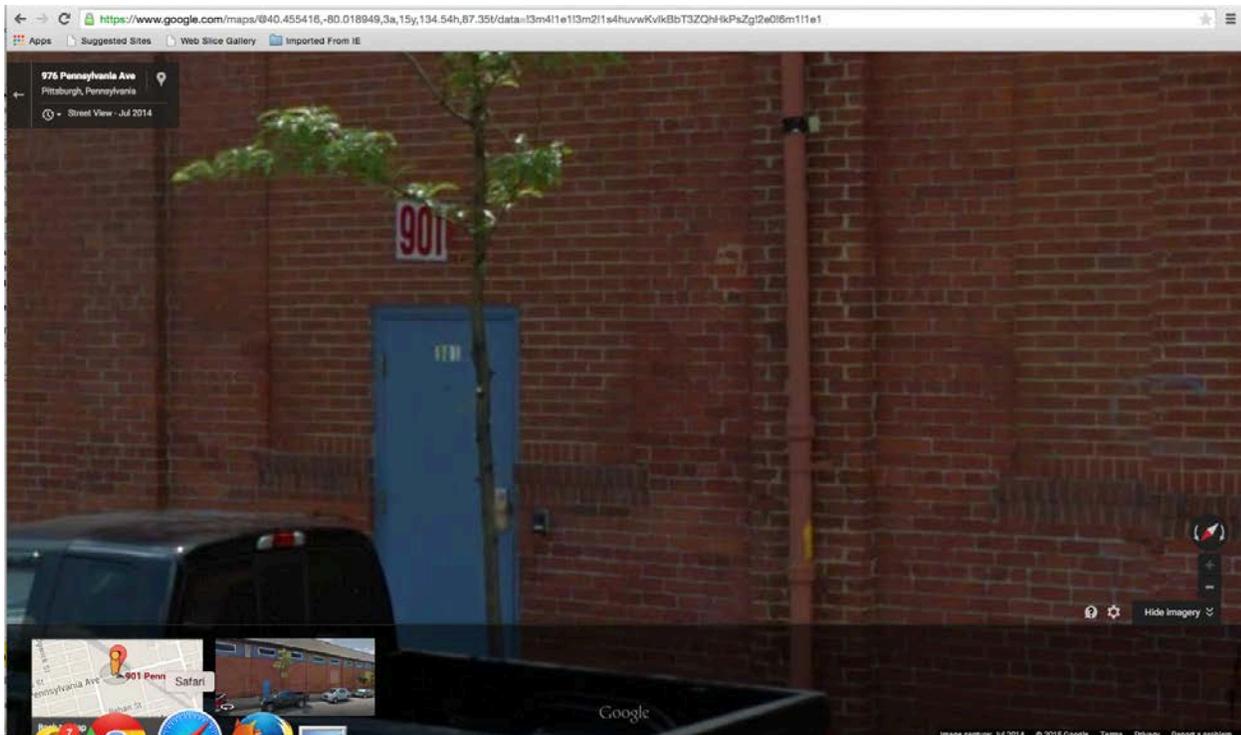
**Suite 901:**

solutions4networks was met at suite 901 by Elizabeth Dell after a call was placed to her cell phone and was asked to provide driver's license identification and a business card before access to the building was granted.

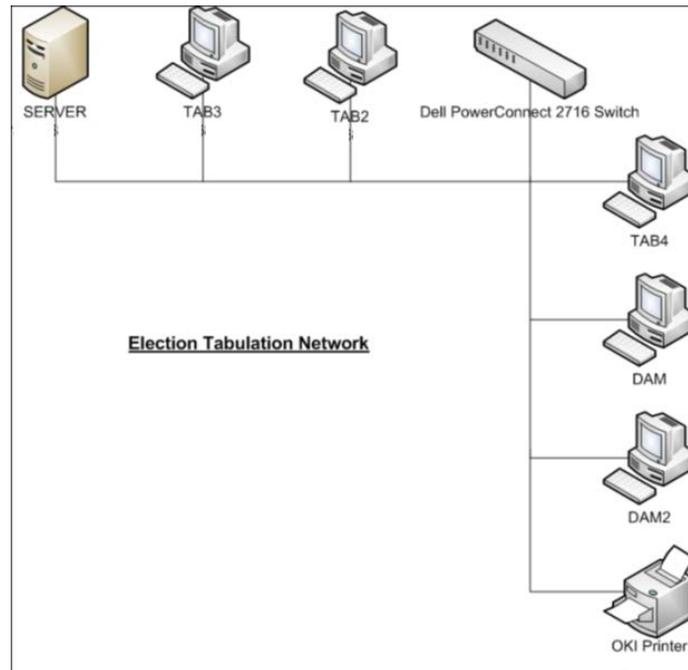
Figure 1 - Election Tabulation Network

A Network Topology diagram was provided to solutions4networks. The observed network topology was identical to the provided drawing.

The Election Tabulation Network consisted of the following devices:

- 1 Dell Powerconnect 2716 Ethernet Switch
- 1 Windows Server
- 5 Client PC's
  - Two DAM (Dial Access Modem) Servers
  - 3 Windows XP Clients
- 1 Printer

All of the devices had an address from RFC1918 private network 192.168.1.0/24. The Windows Server with address 192.168.1.20 provided DHCP, DNS and WINS services. A default gateway of 192.168.1.1 was configured, but no such device was found on the network.

The Dell switch is easily accessible on the countertop. A locked cabinet would make it more difficult to connect an external cable. It is also recommended to disable any unused ports on the Dell Switch or move the unused ports to a different VLAN from the production network.

The DHCP server is giving the clients a default gateway of 192.168.1.1 even though no device exists. Removing the default gateway completely would make it more difficult for the clients to communicate with external networks. There is some inconsistency on the network in that not all of the clients are set up for DHCP. Either set them all up for DHCP or set them all up for Static. For a more secure environment it would be better to disable DHCP on the BOE server entirely and configure static IPs on all of the clients that way if someone were to ever connect to the Dell switch they would never obtain a DHCP address but would have to know the network addressing to hard code their PC.
